228  
ACC. 2  
TES IV  
CONTRACT NO. 68-01-7351  
EPA WORK ASSIGNMENT NO. R07008  
JACOBS WORK ASSIGNMENT NO. 863.  
FINAL  
RCRA FACILITY ASSESSMENT REPORT  
COLLIS INCORPORATED  
CLINTON, IOWA

PREPARED BY  
JACOBS ENGINEERING GROUP INC.  
12600 WEST COLFAX AVENUE, SUITE A300  
LAKEWOOD, COLORADO 80215

OCTOBER 28, 1988

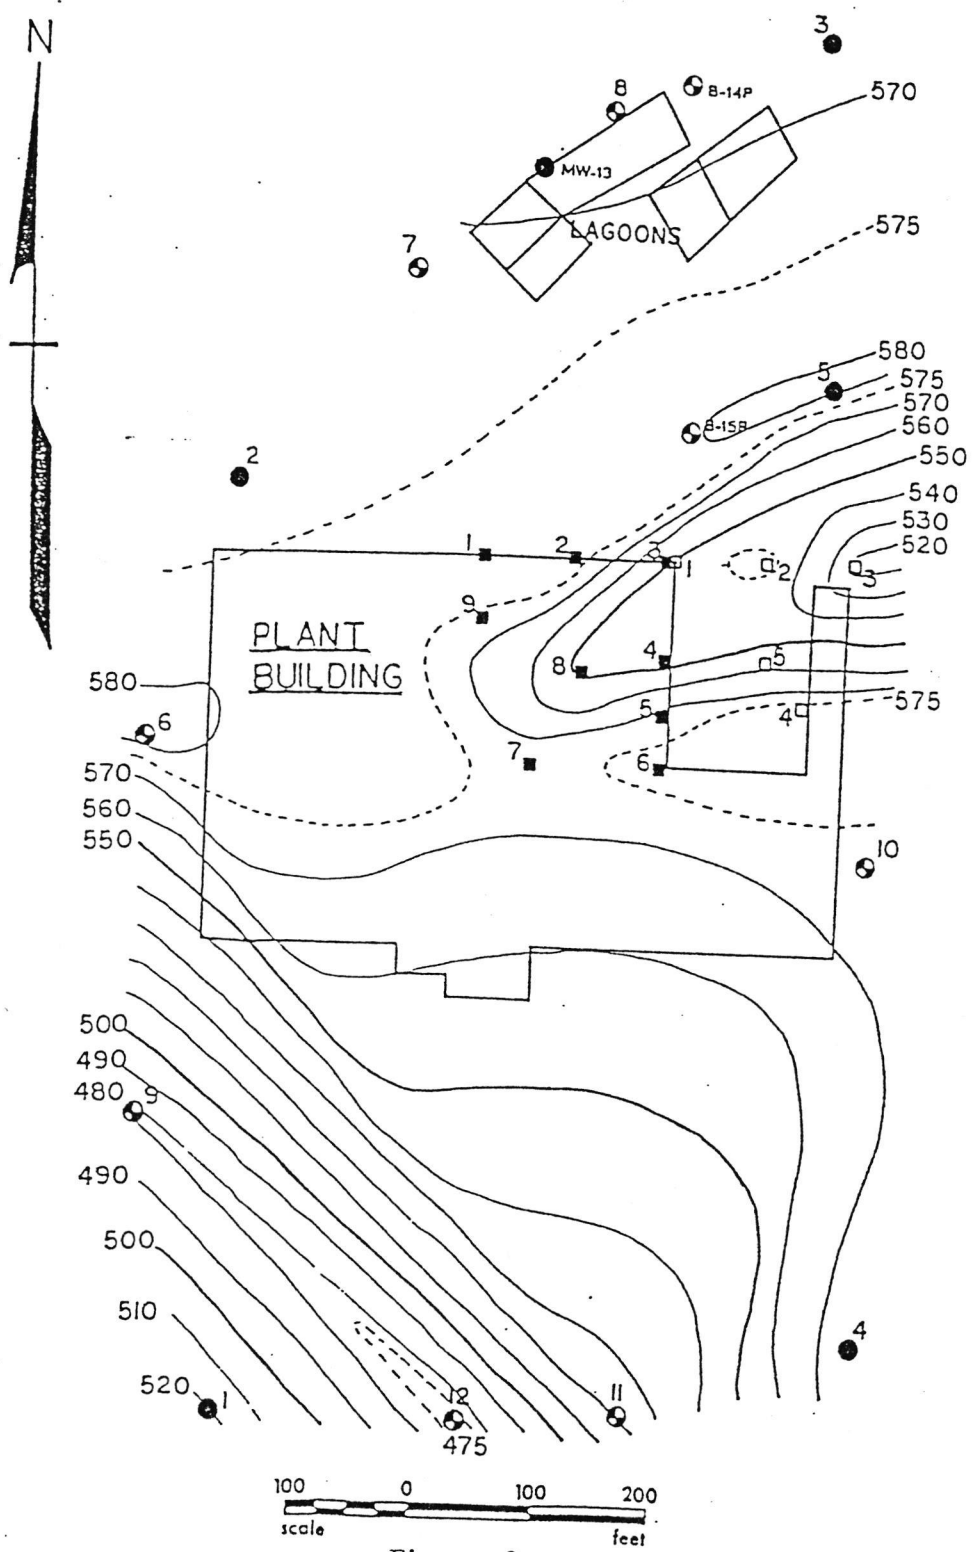
Figure 3.  
Bedrock Topographic Map  
Source: [18]

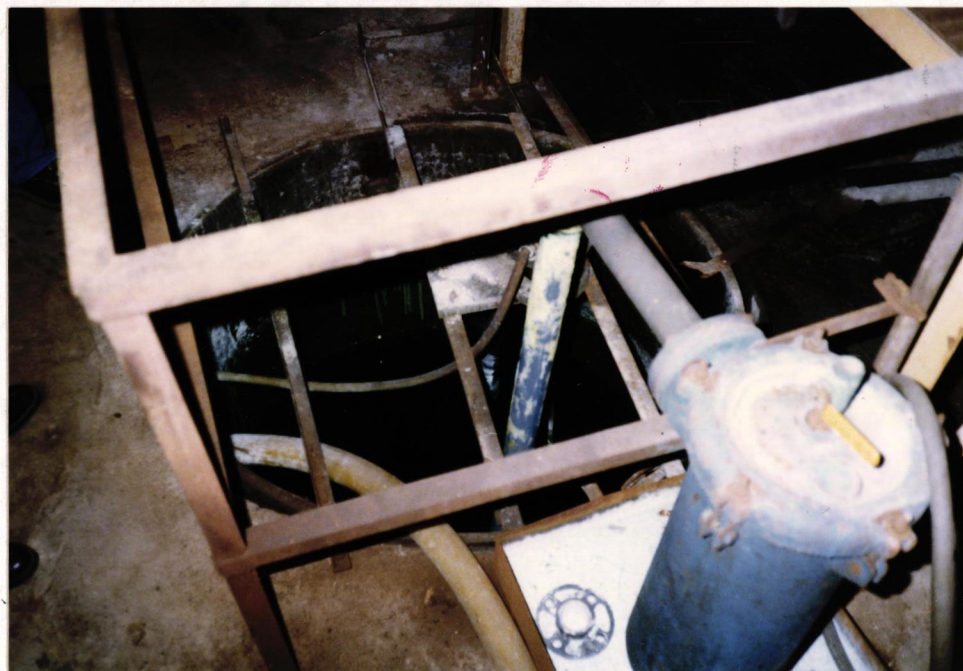
**PHOTOGRAPH # 3**  
**OFFICIAL PHOTOGRAPH - JACOBS ENGINEERING**

**Subject:** Zinc plating area chromate sump

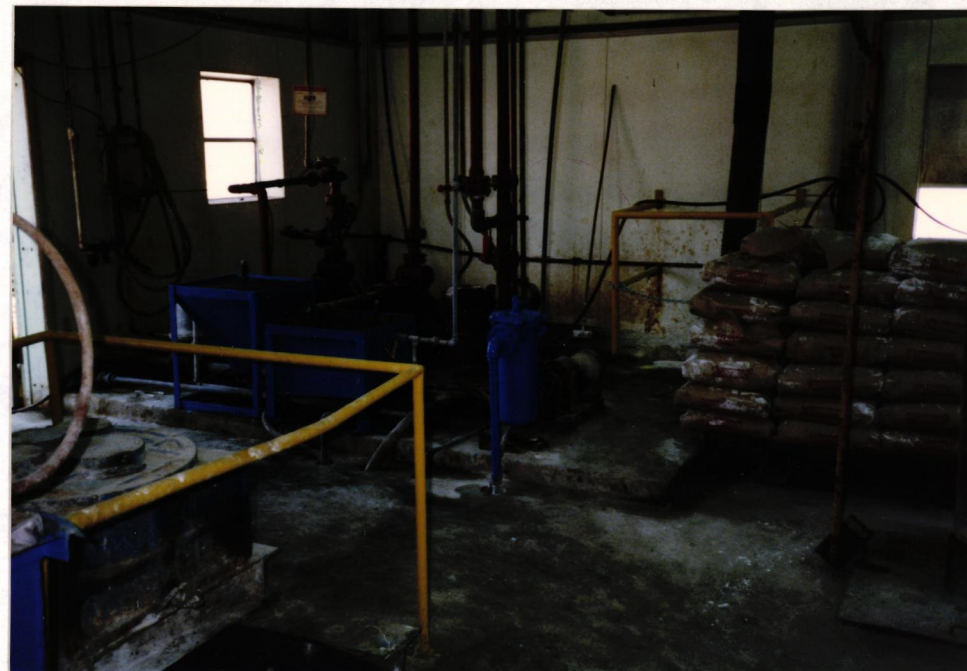
**PHOTOGRAPH # 4**  
**OFFICIAL PHOTOGRAPH - JACOBS ENGINEERING**

Evidence of Release During the VSI, it was not possible to inspect the integrity of the tanks due to the concrete pad cover and the active operation of the tanks at that time. No evidence of release has been previously documented; however, no leak detection system or ground-water monitoring capability exists adjacent to the tanks. It should be noted that the bases of the ten foot deep subgrade tanks are probably beneath the facility's shallow ground-water table.

**Subject:** Chrome treatment tank; below  
concrete pad in corner

- Recommendations. The facility needs to substantiate the integrity of the chrome treatment tanks and assure that waste materials are not migrating into the shallow ground-water system. This may include a thorough inspection and assessment of the overall condition of the units when empty and not actively operating. It may also include the collection and analysis of soil and ground-water samples adjacent to the tanks. No additional evaluation of the chrome treatment tanks, as part of this RFA, is recommended at this time.

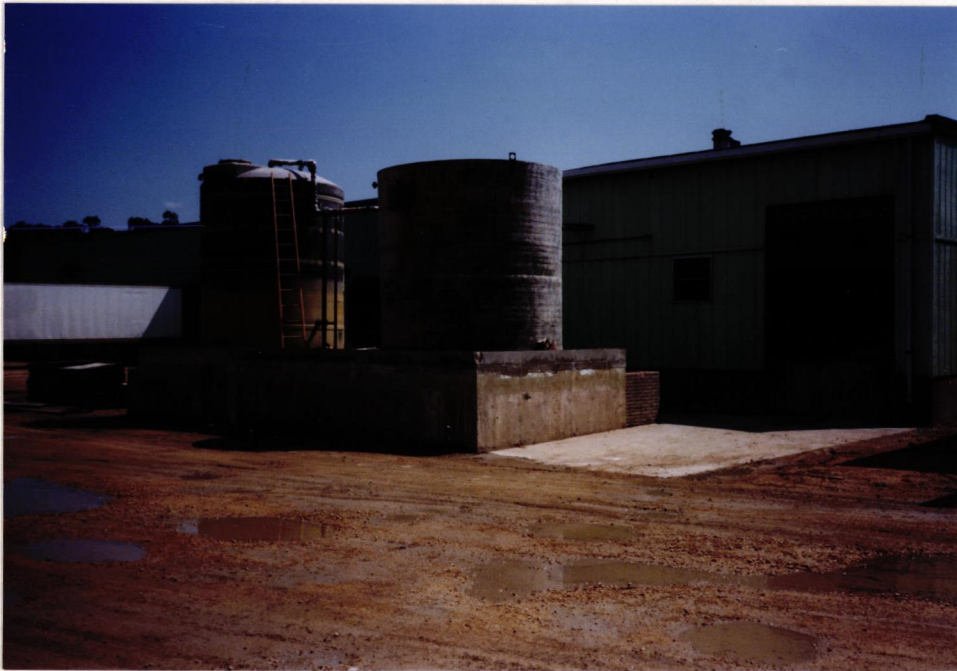
**PHOTOGRAPH # 5**  
**OFFICIAL PHOTOGRAPH - JACOBS ENGINEERING**

**Subject:** Spent acid tank (left) and spent cleaner tank (right)

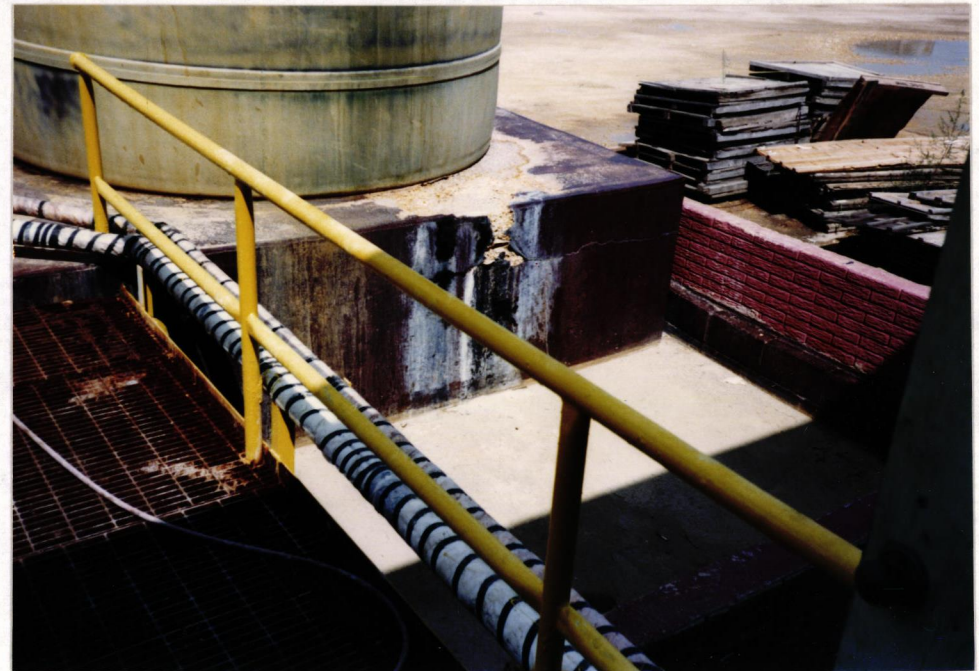
**PHOTOGRAPH # 6**  
**OFFICIAL PHOTOGRAPH - JACOBS ENGINEERING**

containment wall (Appendix 1, Photograph 6). Facility personnel, questioned during the VSI, indicated that spent acids are stored in the tank for one to two weeks before neutralization. The facility has utilized a spent acid tank since the WWTP was constructed in 1970; however, the current tank is a replacement, having been installed in 1987. The spill containment structure was added in 1980 or 1981 [7].

Evidence of Release Leakage from the tank was evident during the VSI in the form of minor staining and erosion of the tank's concrete pad (Appendix 1, Photograph 6). It was not clear whether the release was on-going or from a previous leak which had since been repaired. It is also possible that the leak was from the tank replaced in 1987. There was no evidence of a breach in the tank's containment system, however. There is no documentation of previous releases from the unit.

**Subject:** Containment structure and apparent leak, spent acid tank

- Recommendations. The facility should correct or document previous repairs to the apparent leak, observed during the VSI, in the spent acid tank. No additional evaluation of the unit, as part of this RFA, is recommended at this time.

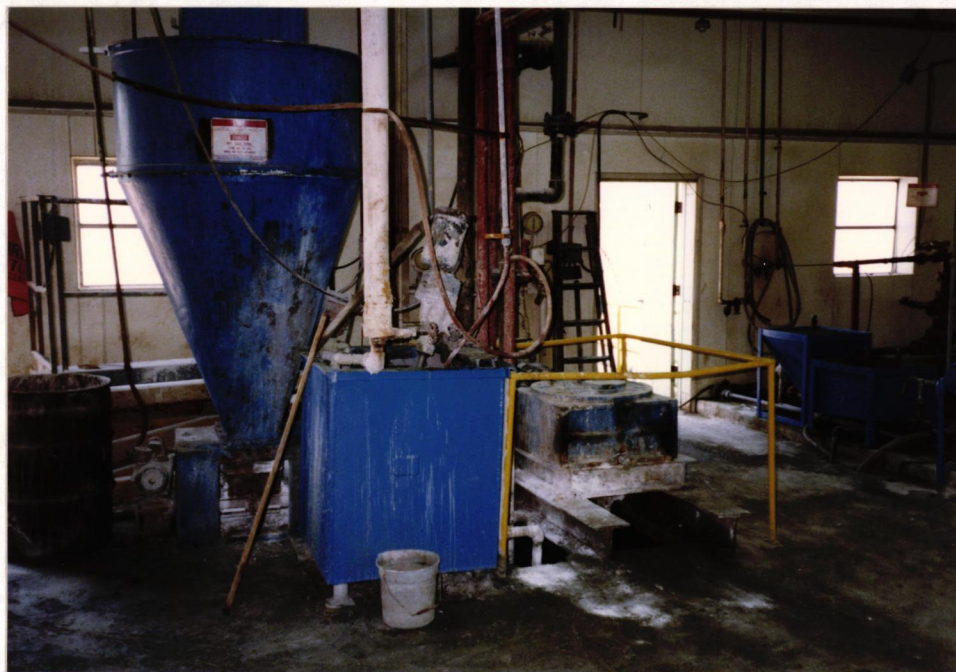
**PHOTOGRAPH # 7**  
**OFFICIAL PHOTOGRAPH - JACOBS ENGINEERING**

**Subject:** Spent kolene salt tank (blue bin)  
and neutralization tank (under concrete pad)

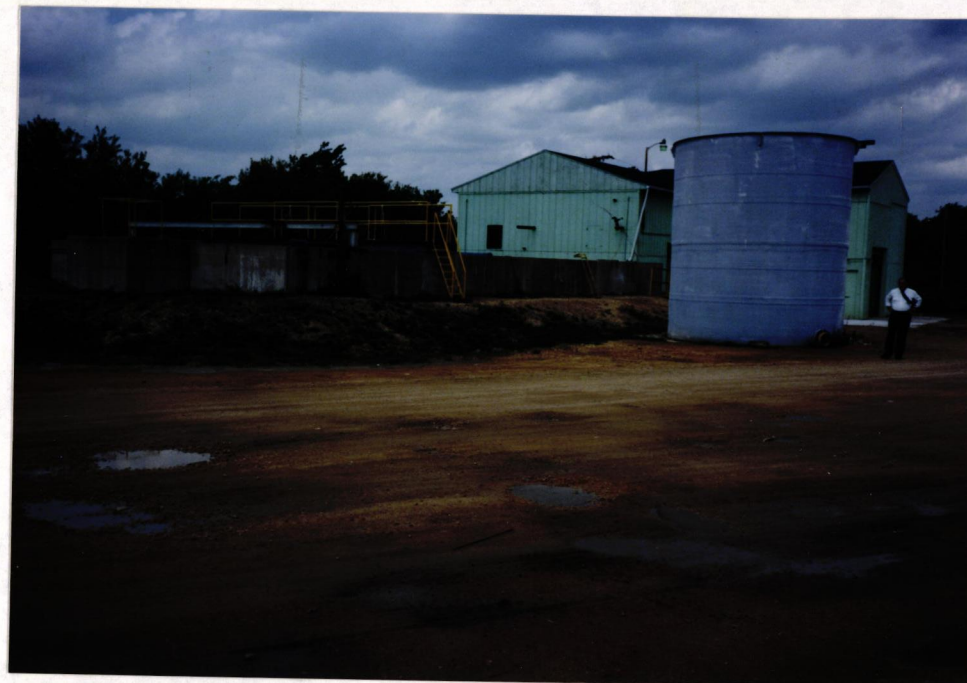
**PHOTOGRAPH # 8**  
**OFFICIAL PHOTOGRAPH - JACOBS ENGINEERING**

**Subject:** Settling basin (left), temporary  
storage tank (right), and filter  
house (background)

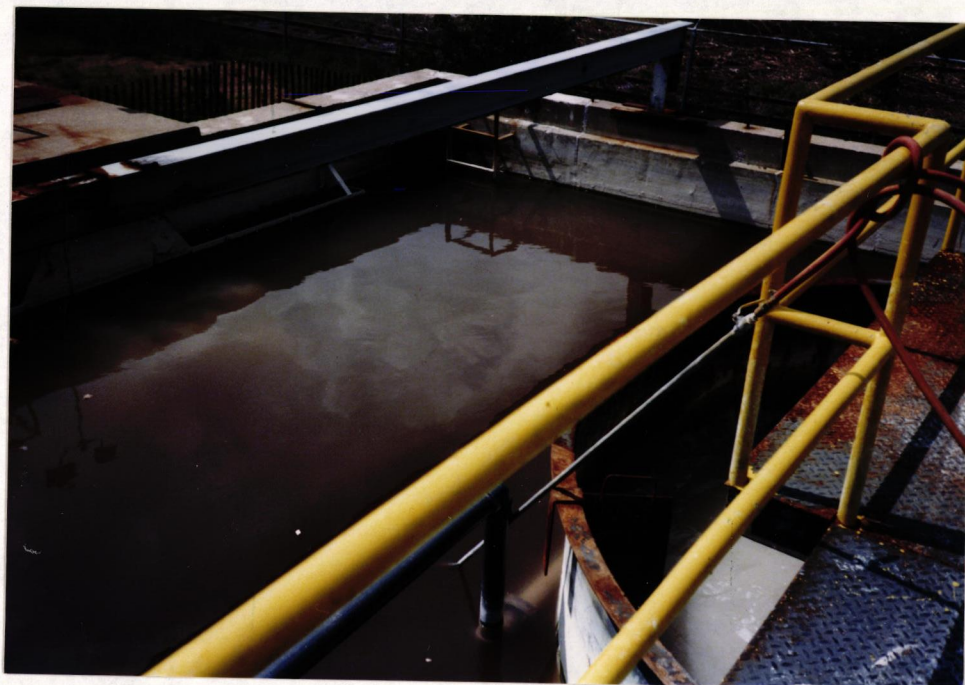
**PHOTOGRAPH # 9**  
**OFFICIAL PHOTOGRAPH - JACOBS ENGINEERING**  
**Subject:** Settling basin interior

Evidence of Release During the VSI, the facility was maintaining only about three feet of freeboard in the settling basin which rendered inspection of the integrity of the unit impossible (Appendix 1, Photograph 9). No evidence of a release to ground water has been previously documented; however, no leak detection system or ground-water monitoring capability exists adjacent to the unit. Documentation indicates that overtopping has previously occurred releasing waste materials to surface soils and surface water bodies [5]. No evidence of recent overtopping was observed during the VSI, however.

- Recommendations. The facility needs to substantiate the integrity of the settling basin and assure that waste materials are not migrating into the shallow ground-water system. This may include a thorough inspection and assessment of the overall condition of the unit when empty and not actively operating. It may also include the collection and analysis of soil and ground-water samples adjacent to the tank. No additional evaluation of the unit, as part of this RFA, is recommended at this time.

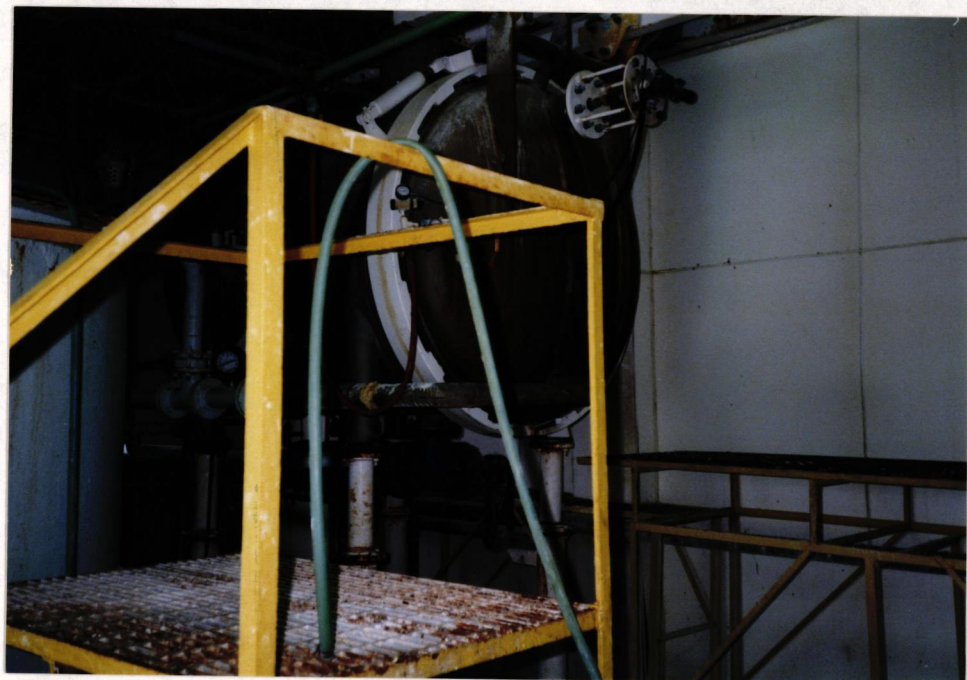
**PHOTOGRAPH # 11**  
**OFFICIAL PHOTOGRAPH - JACOBS ENGINEERING**

**Subject:** Filter house diatomaceous earth final effluent filter

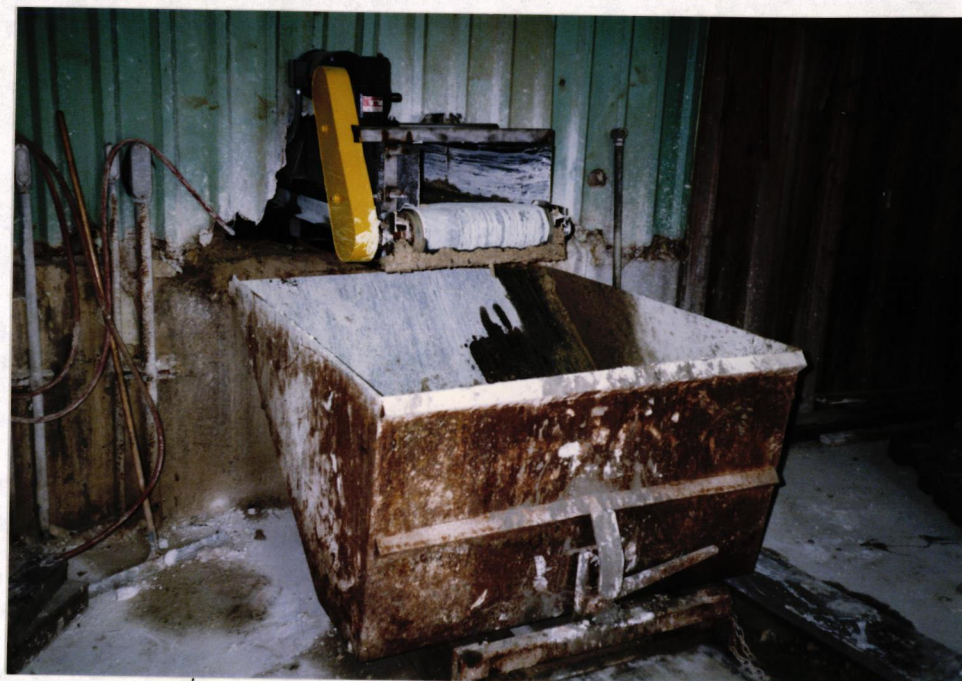
**PHOTOGRAPH # 12**  
**OFFICIAL PHOTOGRAPH - JACOBS ENGINEERING**

**Subject:** Filter house sludge conveyor belt and sludge bin

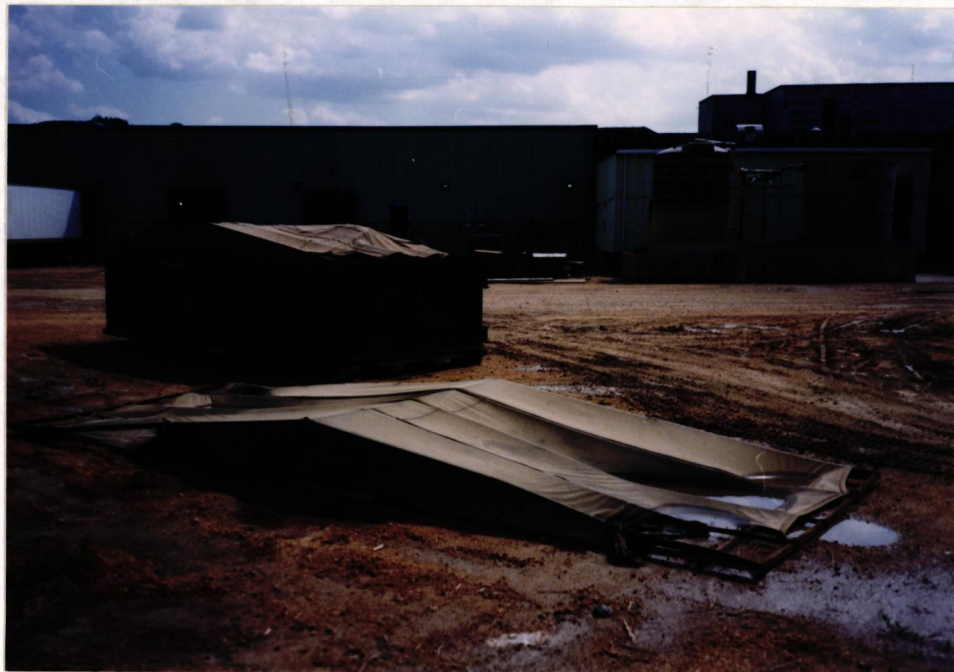
**PHOTOGRAPH # 13**  
**OFFICIAL PHOTOGRAPH - JACOBS ENGINEERING**

**Subject:** Sludge hopper and canvas cover

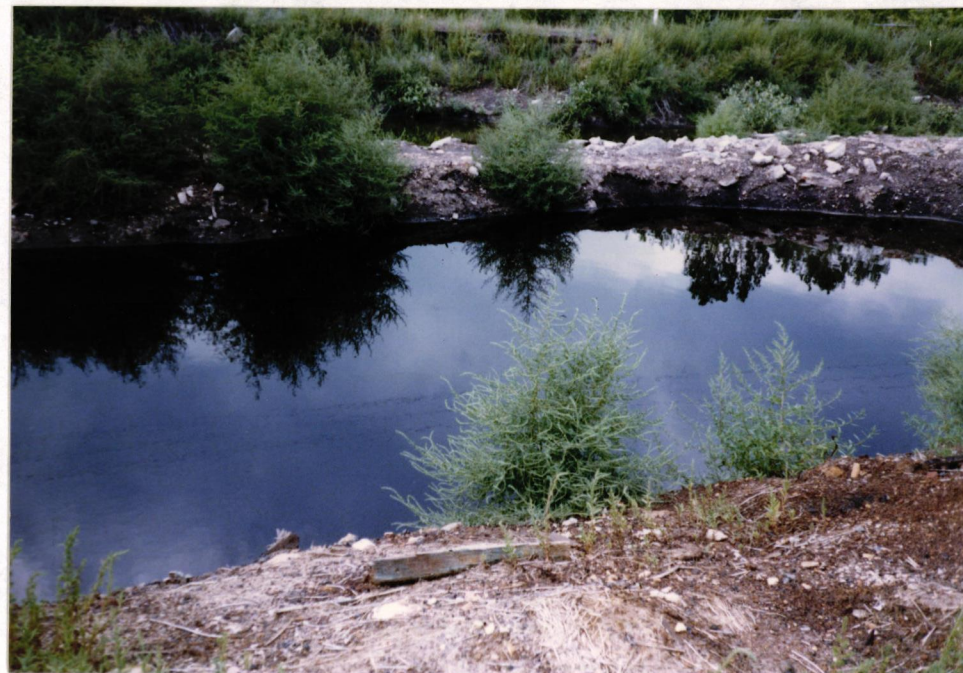
**PHOTOGRAPH # 14**  
**OFFICIAL PHOTOGRAPH - JACOBS ENGINEERING**

**Subject:** Sludge impoundment #3, note oily staining on impoundment sides

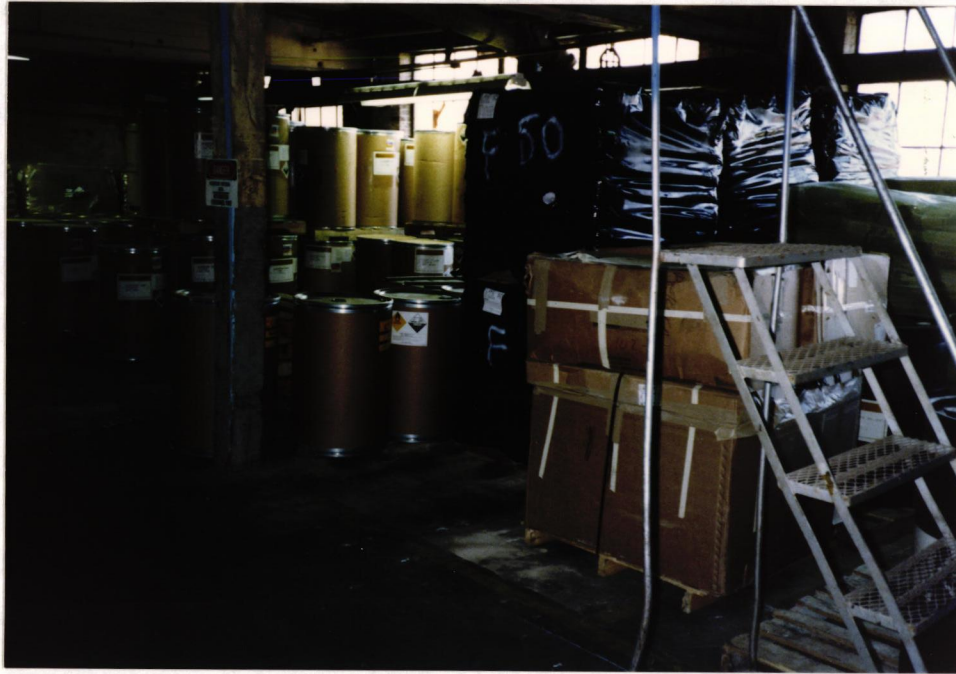
**PHOTOGRAPH # 15**  
**OFFICIAL PHOTOGRAPH - JACOBS ENGINEERING**

**Subject:** Chemical storage area

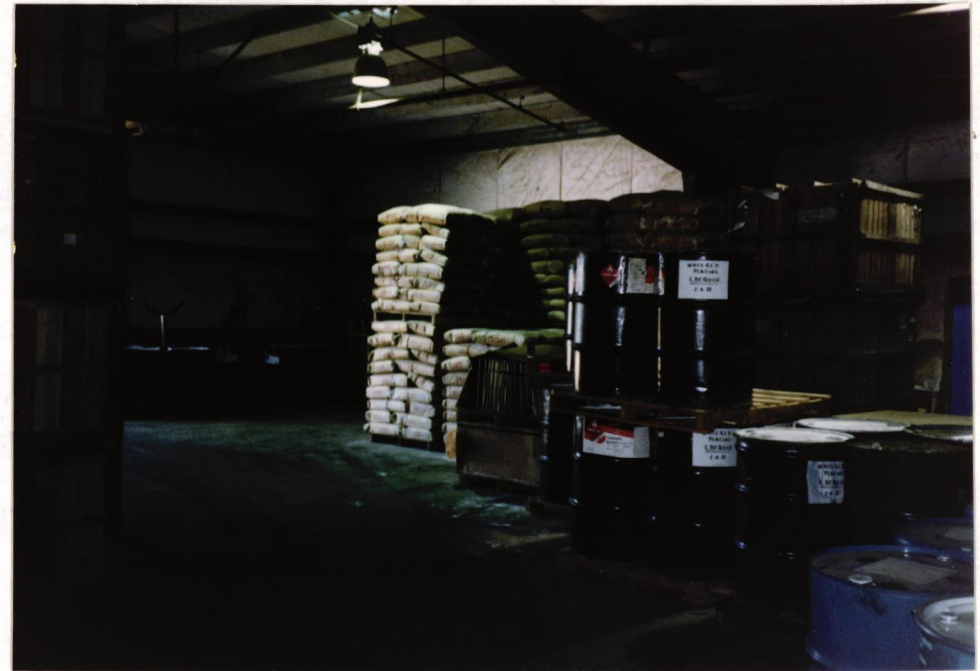
**PHOTOGRAPH # 16**  
**OFFICIAL PHOTOGRAPH - JACOBS ENGINEERING**

**Subject:** Receiving dock inside container storage area

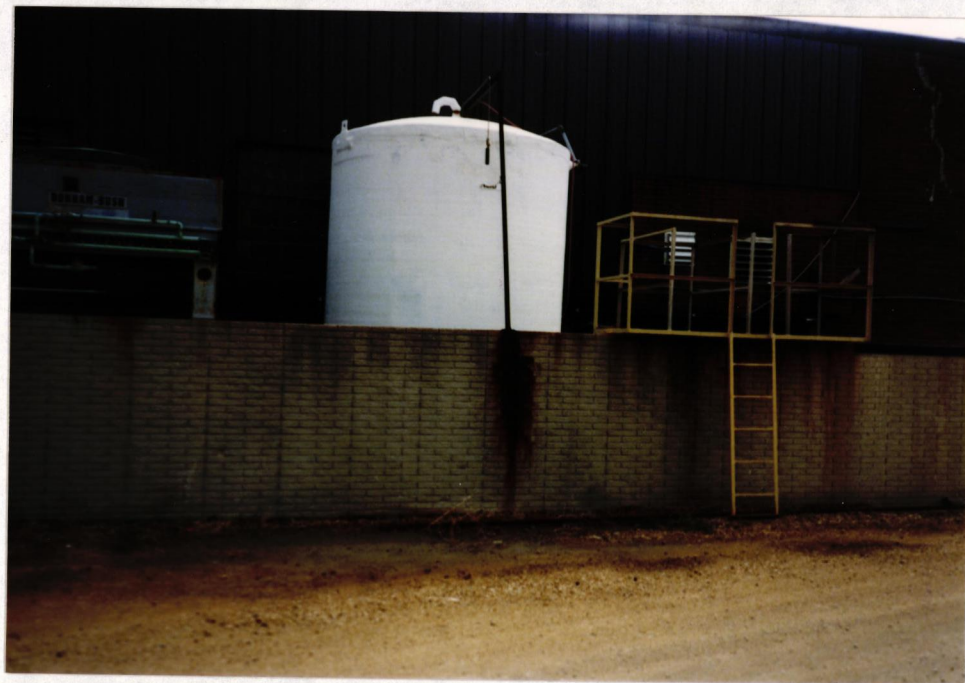
**PHOTOGRAPH # 17**  
**OFFICIAL PHOTOGRAPH - JACOBS ENGINEERING**

**Subject:** Chromic acid storage tank

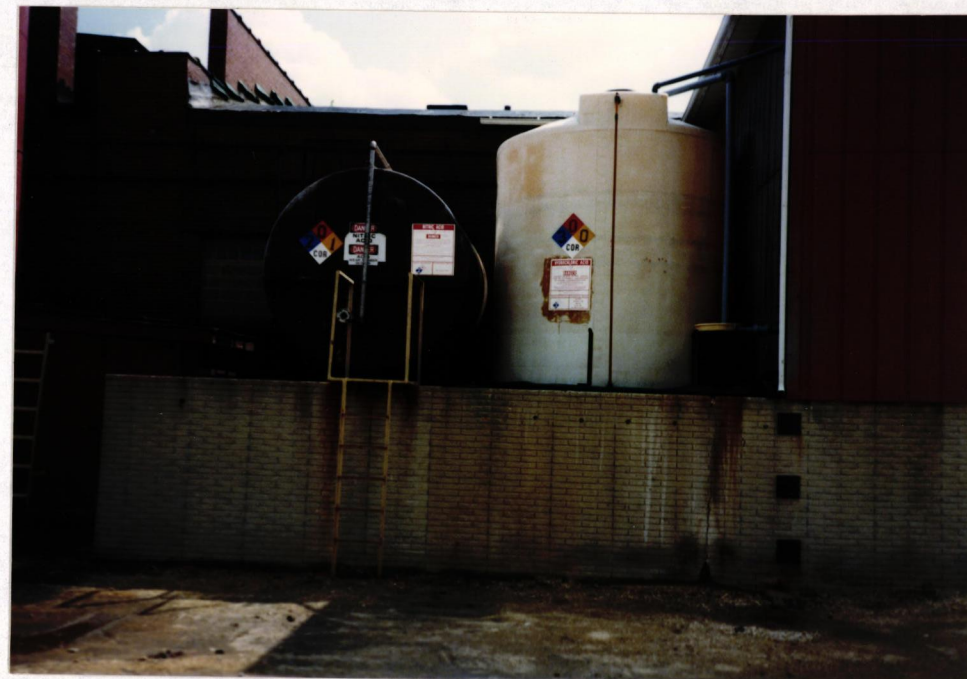
**PHOTOGRAPH # 18**  
**OFFICIAL PHOTOGRAPH - JACOBS ENGINEERING**

**Subject:** Nitric acid storage tank (left), HCl  
acid storage tank (right)

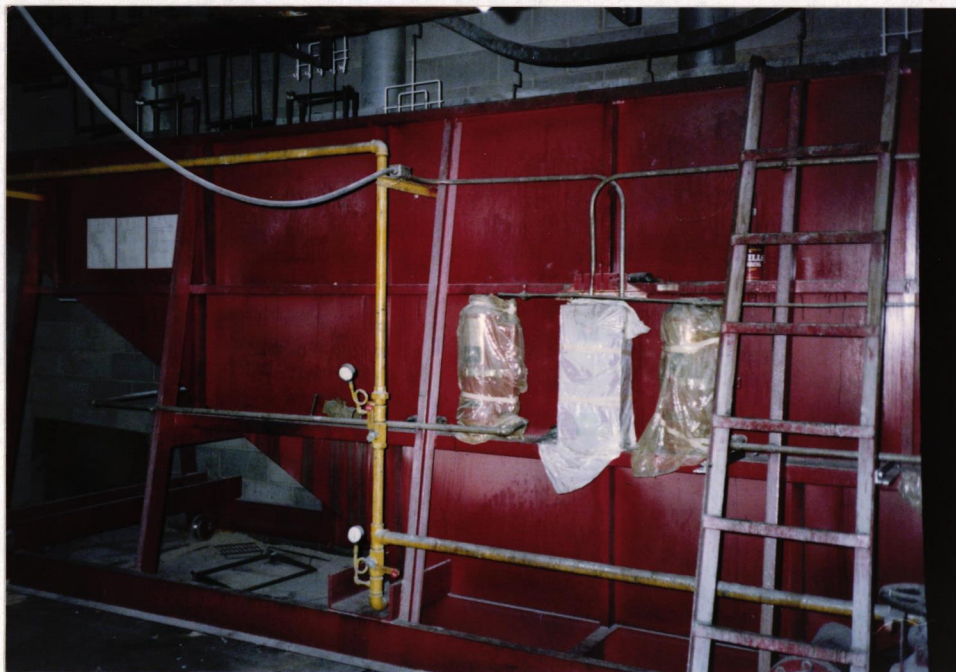
PHOTOGRAPH # 19  
OFFICIAL PHOTOGRAPH - JACOBS ENGINEERING  
Subject: Epoxy lacquer tank
